### Sitka National Historical Park Sitka, Alaska

# Tech Notes

## EXTERIOR WOODWORK

### Protecting Woodwork Against Decay Using Borate Preservatives

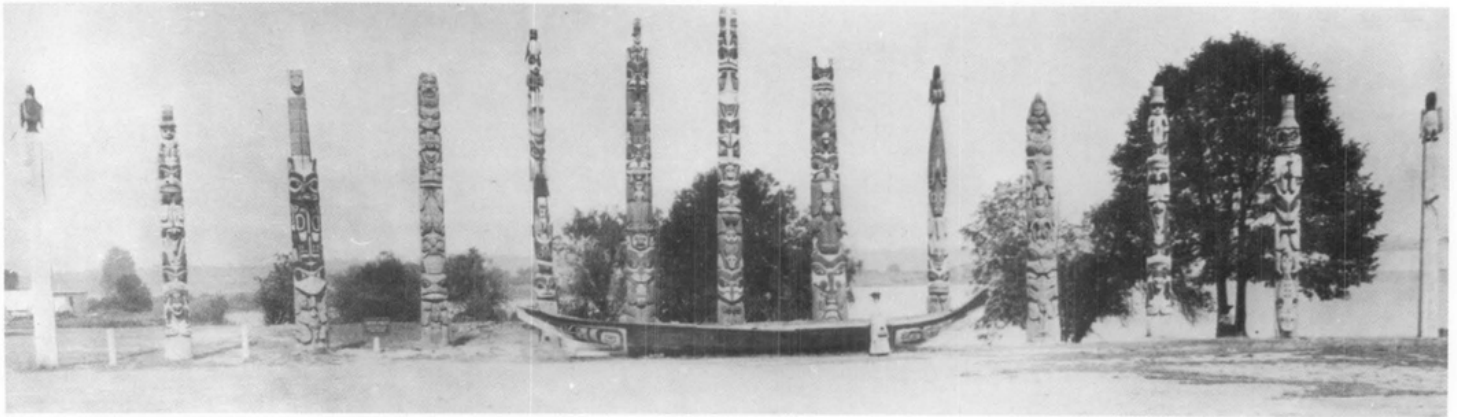
Figure 1. Some of the Sitka totem collection shown on display at the 1904 Louisiana Purchase Exposition. Totem poles (totems) generally serve one of four purposes: crest poles give the ancestry of a particular family; history poles record the history of a clan; legend poles illustrate folklore or real life experiences; and memorial poles commemorate a particular individual. The first recorded sightings were by European explorers and traders in the late 18th century. Detached exterior poles reached their zenith in the late 19th century, standing along the village fronts of the Haida and Tlingit Indians of northern British Columbia and extreme southeast Alaska.

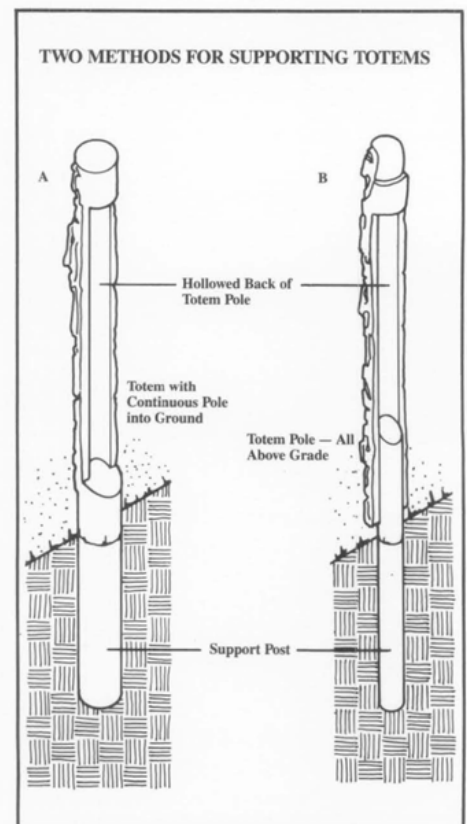
Figure 2. Two methods existed for securing the totems in place. Each of the 3 totems replicated by the Civilian Conservation Corps consisted of one continuous pole which extended into the ground (A). The other 4 totems did not extend into the ground but, rather, were attached to a separate supporting post (B). Due to the deteriorated wood below grade, all 7 totems are being re-erected using separate support posts (B). Drawing: Timothy Buehner.

to deterioration. All 7 poles were hollowed out on the back side at varying lengths above ground. Four poles (Waasgo Legend, Lakich'inei, Yaadaas Crest and Raven/Shark) were mounted with steel bolts onto separate supporting posts that were set into the ground (see figure 2). The Mosquito Legend, Trader Legend and Frog Raven replicas, carved by the Civilian Conservation Corps, have concave backs (above ground only), with the full butt section of the carved poles extending into the ground — the original method for erecting totems.

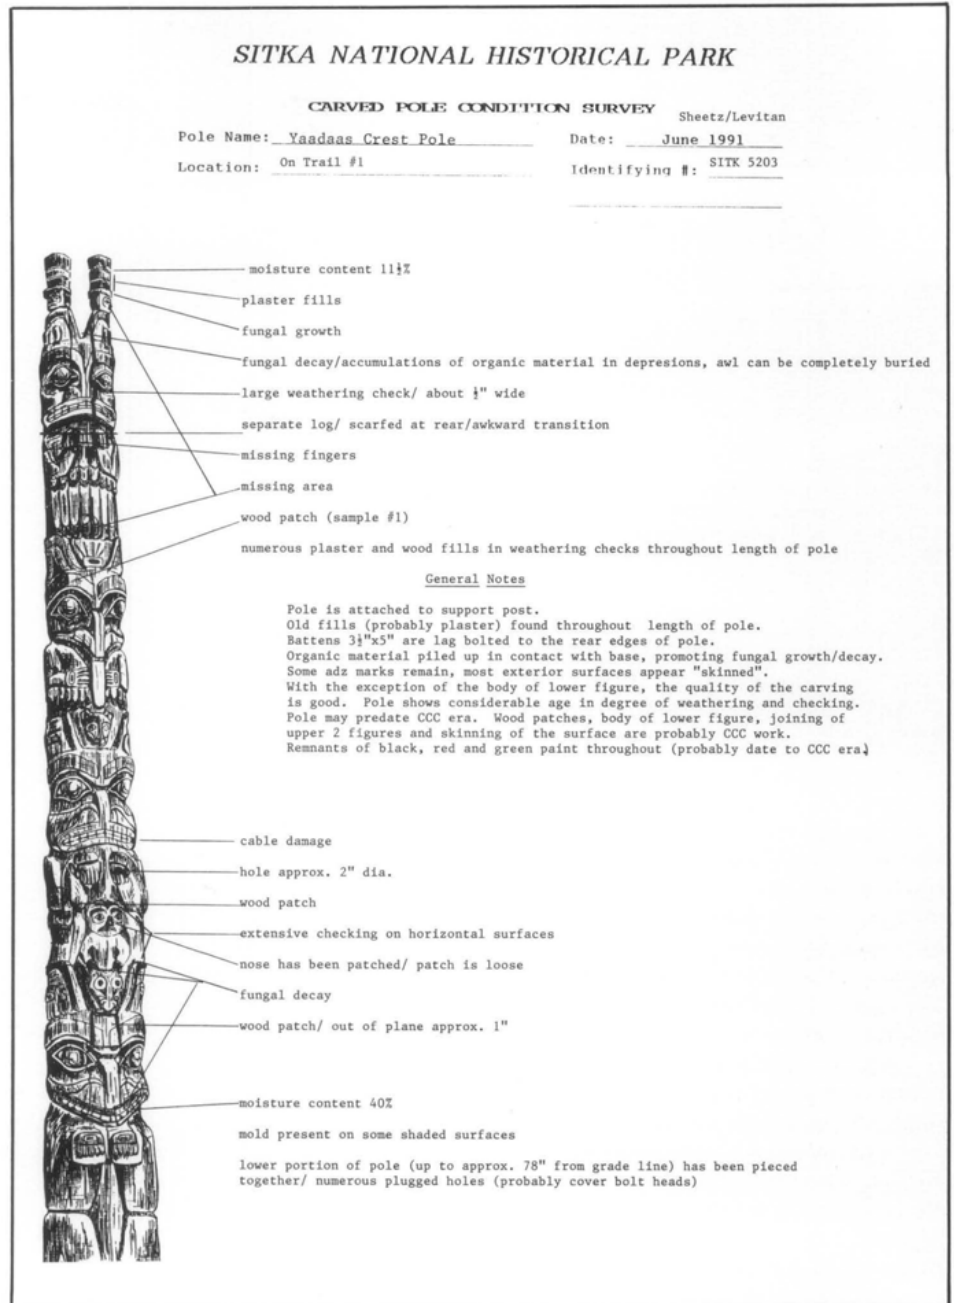
Figure 3. A condition survey of each of the 7 totem poles identified a variety of problems, including fungal decay, cracks and splits, and high moisture levels.

In 1991, a 3-day Totem Preservation Conference was held in Sitka to evaluate preservation approaches and a condition survey made of the collection. The survey included 30 carved poles and carved house poles at the park; some were on display and others were in storage (see figure 3).

The 7 poles determined to be in the most advanced state of decay shared several characteristics. They were all displayed outside and, in consequence, their bases were decayed. In several cases, the moisture content of the wood to 6" above ground was as high as 47% and fungal decay on the surface was clearly evident. Damage to the bases had occurred directly above ground and below grade to a depth of 18".

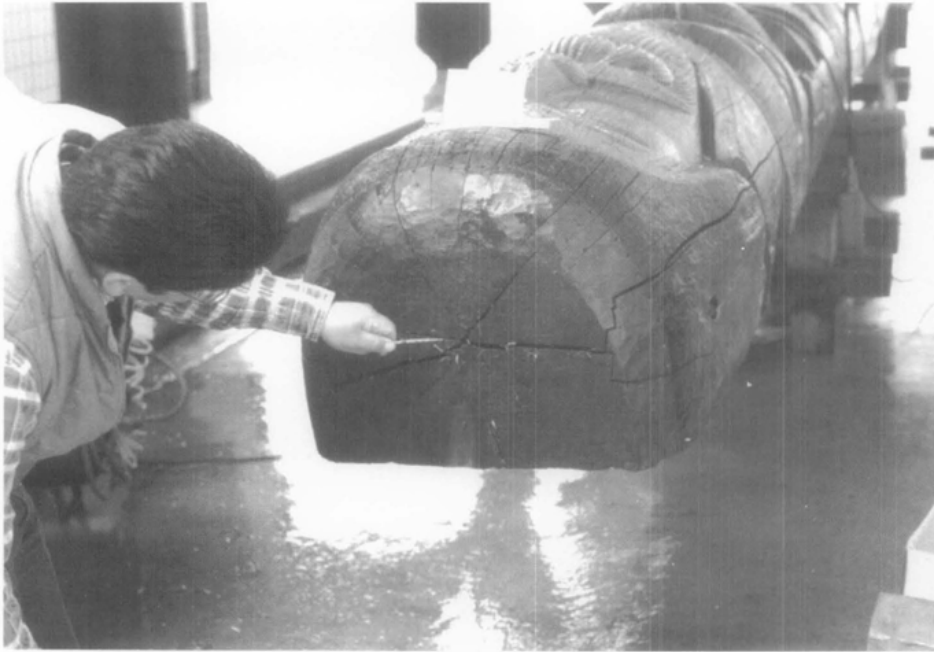
Figure 4. Organic debris had collected in the splits and cracks, contributing to moisture retention and fungal growth.

Although less serious than the damage to the bases, fungal decay also had occurred at other locations. At the top of the poles, the open end grain and cracks in the wood created perfect conditions for water retention (see figure 4). Some of the poles were flat at the top, permitting water ponding. Fungal decay also was evident on the horizontal surfaces of the carvings throughout the length of the poles, in crevices created by carvings, and in the cracks and splits in the wood where organic debris tended to accumulate and retain moisture. One pole had an 8 foot-long vertical split at the base. Finally, decay was evident in the concave backs of the poles that abutted supporting posts (see figure 5).

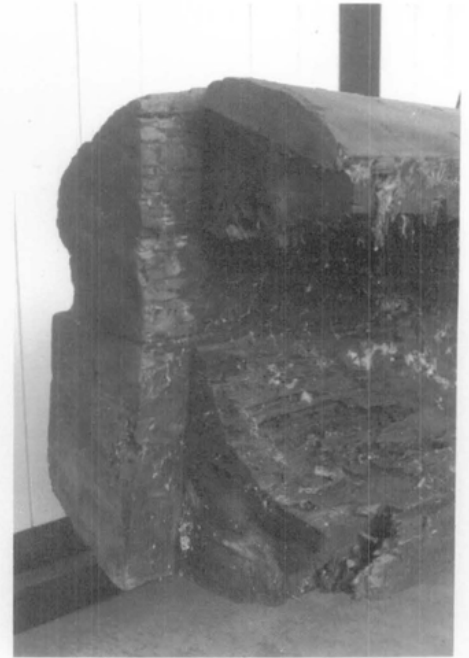
Figure 5. Deterioration occurred between the support post and the hollowed back of the totem. Coal tar had been applied in the past to the hollowed back of this totem to deter fungal decay.

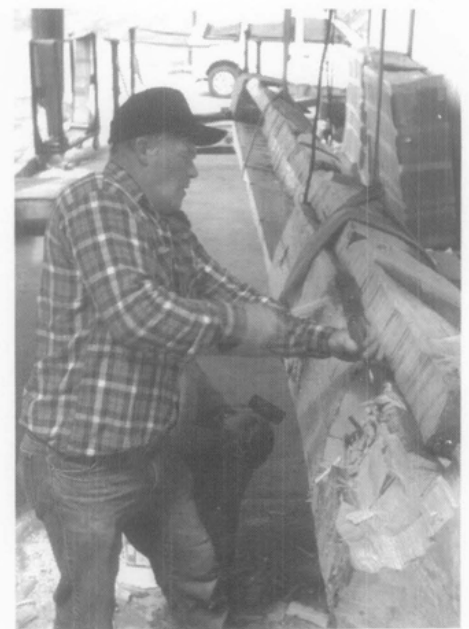
Figure 6. Three of the 7 totems had support posts. The steel bolts connecting the support posts to the totem had rusted and often needed to be chiseled out of the support post. Note the hollowed back of the totem which extended nearly the entire length while the support post extended only about half way.

base. Support posts were detached by removing the 1/2" all-thread steel rods that had connected the posts to the carved poles (see figure 6). The totem poles then were cleaned with water using natural bristle brushes and a garden hose with a spray attachment. Since the red cedar poles had

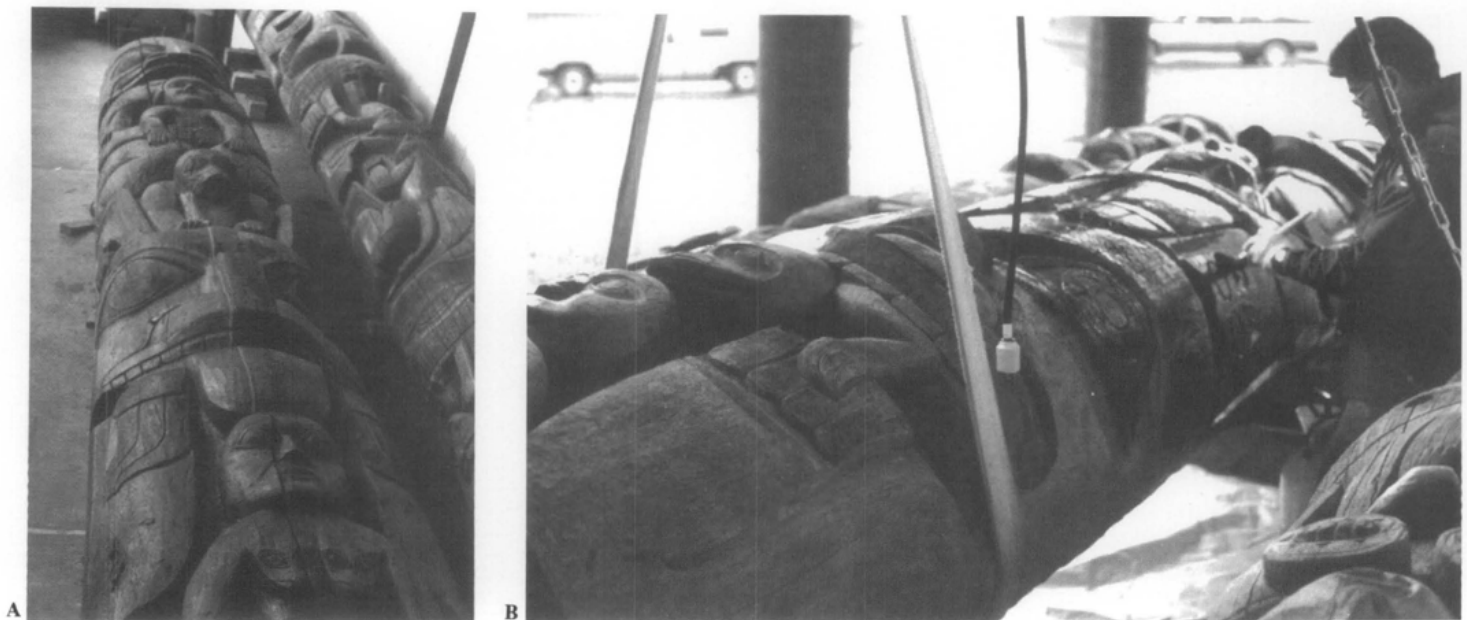
Figure 7. Borates were applied to the totem using a garden sprayer and brushes. This was followed by an application of a water repellent with mildewcide. Photo A is during application and photo B shows totems while drying.

Following repairs, the poles were first treated with a commercially available borate preservative. It was purchased as a concentrate and diluted with warm water in a 1:1 mixture in accordance with label instructions. With the pole on its back, supported by cribbing and padding, the ends were treated with a brush application of the preservative as well as with any end grain exposed by carvings. The preservative was then sprayed onto the rest of the pole using a 2-gallon garden sprayer (see figure 7). This was followed by a second coat, spraying slowly to ensure all cracks and crevices received ample coverage. The poles were sprayed until thoroughly wet and rotated with a chain hoist as needed. Near the surface, where wood was oversaturated with the preservatives, boron salts fluoresced on the surface after the glycol and water evaporated. The fluorescence was removed by wiping with a wet brush. After waiting several days for the surface to dry from the application of the wood preservative, the water repellent and mildewcide mix then was sprayed onto the pole, again using a garden sprayer to apply the mix and a brush to spread it.

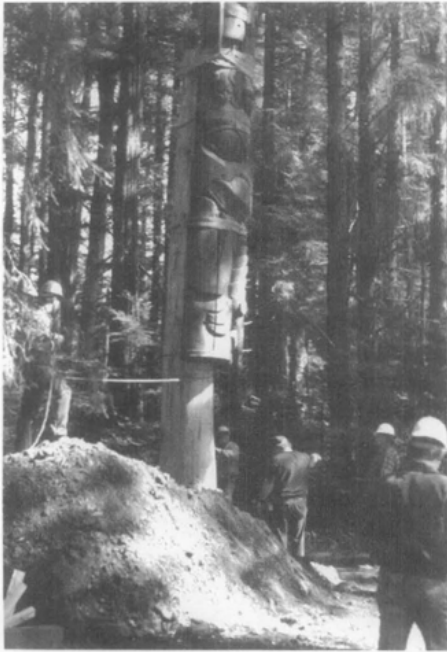
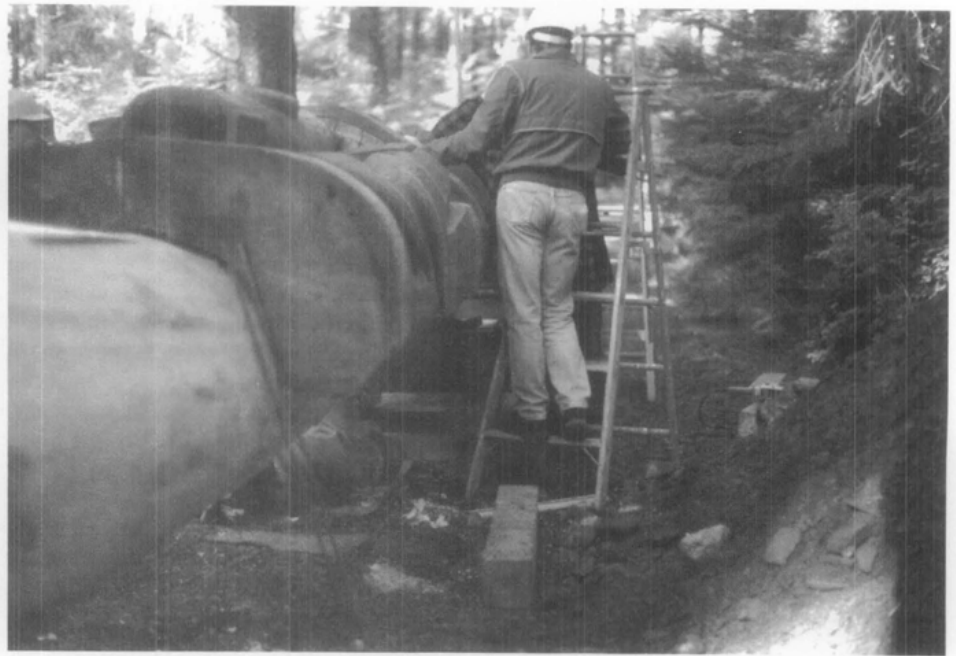
Figure 8. Due to the heavy weight of the totems, they were usually attached to their fitted support post and re-erected at the site.

Upon securing the support post to the totem, the entire unit was re-erected (see figure 8). The prepared bandage was fastened to the support post before the last 20" of fill dirt was added (see figure 9).

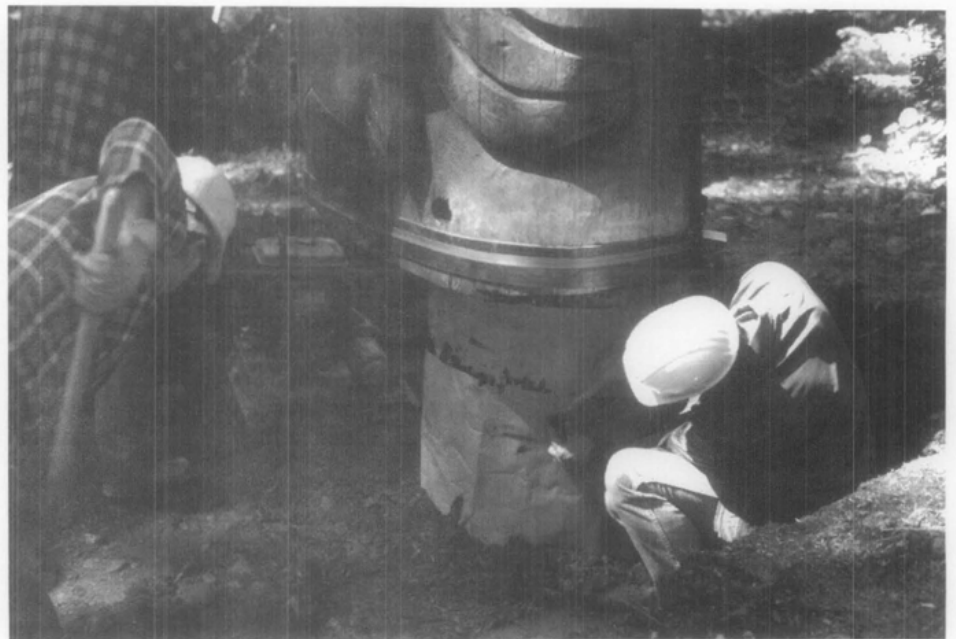
Figure 9. After securing the support post in the ground, a wood preservative in a "bandage" form was attached to the support post before dirt was filled to grade level.

mold and mildew. The utilization of a wrap or bandage was considered the most effective application method and, in addition, it would retard the borate from leaching out of the wood. It is anticipated that the wraps will be inspected in 10 years to assess their condition and possible replacement. (This would only require removal of the dirt around the bases to a depth of approximately 20" so that a new wrap could be applied, if needed.)

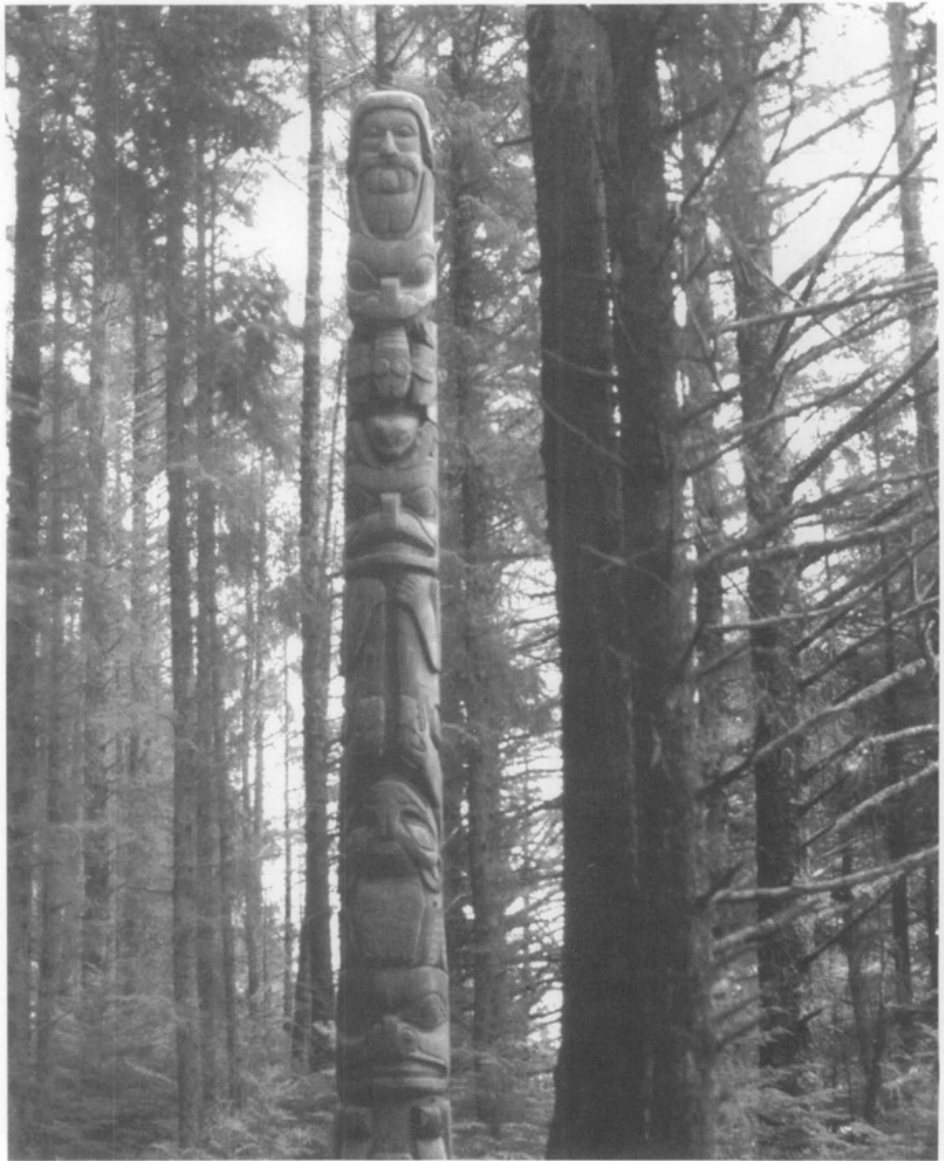
Figure 10. Application of a water repellent to the totems will probably be needed approximately every 3 years. This can easily be done in place. The support post's "bandage" wrap located just below grade, will need to be inspected in about 10 years.

Selected for use on various totem poles at Sitka because of its purported effectiveness and relative safety, borate treatment has potentially broad applications to wooden structures and outdoor artifacts. Log buildings, window sills, and above-ground outdoor wooden objects subject to decay or insect damage are just some of the potential applications. There are commercially available borate preservatives designed for topical applications to seasoned or partially seasoned wood such as that which was applied to the poles at Sitka. Careful monitoring of the carvings on the poles along with the test log will help document the long-term value of borate preservatives when applied to unpainted wood in this moist environment. Successful results will depend in part on regular maintenance of the poles, particularly in removing collected organic debris and in periodically reapplying a water repellent coating (see figure 10).
